KX-UT133 and KX-UT136 BLF Button Specification

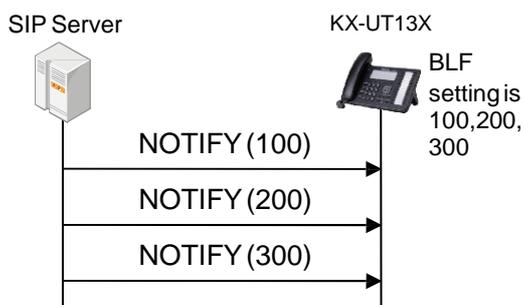
Symptom Occurs

The symptom above will occur when a SIP Server sends multiple “NOTIFY” for BLF to a UT133/136 simultaneously.

When installing KX-UT133/136 in a Group Ring configuration, check the SIP Server specification or contact your SIP Service provider to confirm the “NOTIFY” for BLF method used.

If multiple SIP “NOTIFY” for BLF are sent individually by the SIP Server or SIP Service Provider, request to have this changed to one “NOTIFY” for BLF by list.

If SIP “NOTIFY” for BLF is sent individually and cannot be changed, reduce the number of BLF Buttons programmed on the UT133/136 to a maximum of 6.

If more than 6 BLF buttons are needed, install the KX-UT248-B or KX-UT670-B for the application.

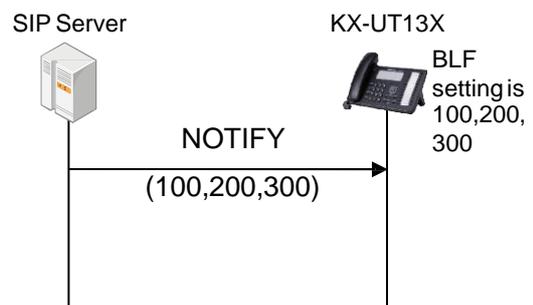
UT13X Operation is Successful

If the SIP Server sends one “NOTIFY” for BLF containing the list for multiple BLF’s, this symptom will not occur.

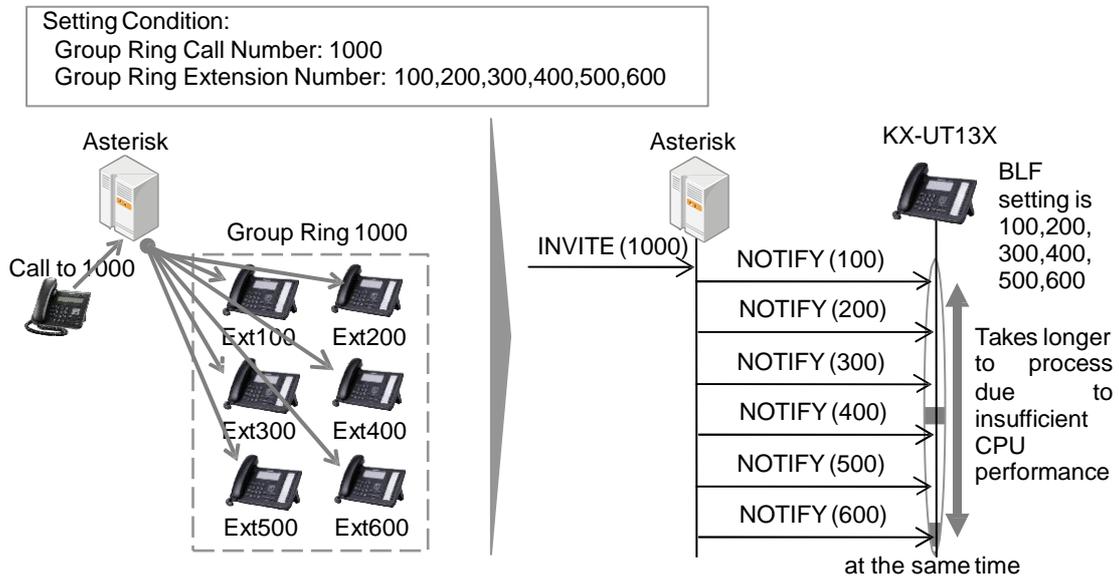
Example:

Panasonic has discovered that Asterisk and (Asterisk-based) SIP Service Providers may send multiple “NOTIFY” for BLF to the SIP end-point for each individual BLF button simultaneously.
